Fatigue reinforcement during repainting for two motorway bridges

Fatigue Design 2019

Jacques BERTHELLEMY^{a*}, Asma MANAI^b^a*Cerema, France*^b*Chalmers university of technology, Sweden*

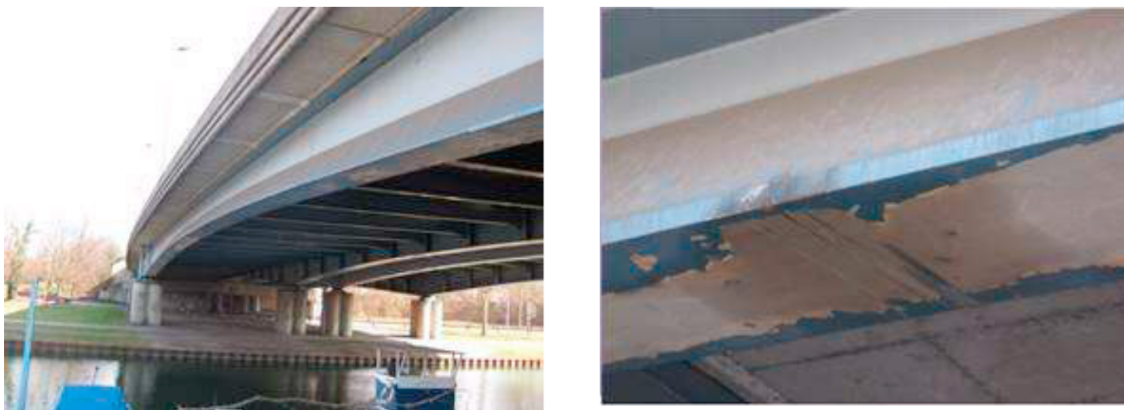
- ✓ **reinforcement of the bottom flange regarding the impact of oversized vehicles.** It was not the case for the Dancourt bridges but it was determinant and efficient for the bridges in Strasbourg presented in Figure 9.

Figure 9 : *Bridges of the ring of Strasbourg at the crossing of the street "des Bouchers"*

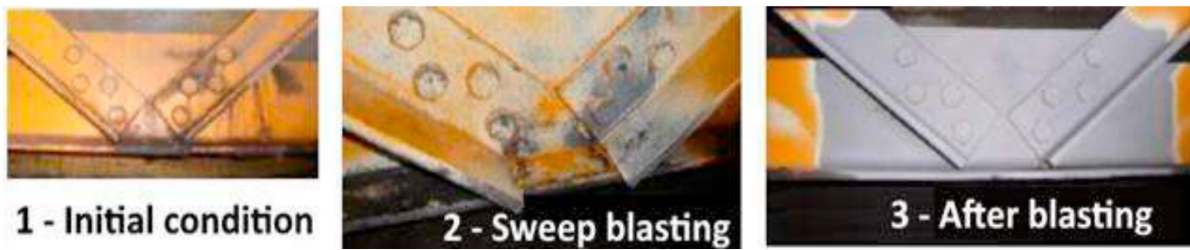
Figure 17 shows the steps for the re-painting work. The quality of the technical proposals of the companies (containment, ventilation, organization of the dressing rooms for the workers, measurements of control) belonged to the criteria of judgment of the offers. Abrasive and UHP-water were the two possible techniques for sweep blasting.

Figure 17 : *Intermediate transverse beam at different blasting levels*
